# DSPA-5 Deployment Evaluation

## Rescue Services Enköping-Håbo

Deployment: Fire in garage, august 24th 2011

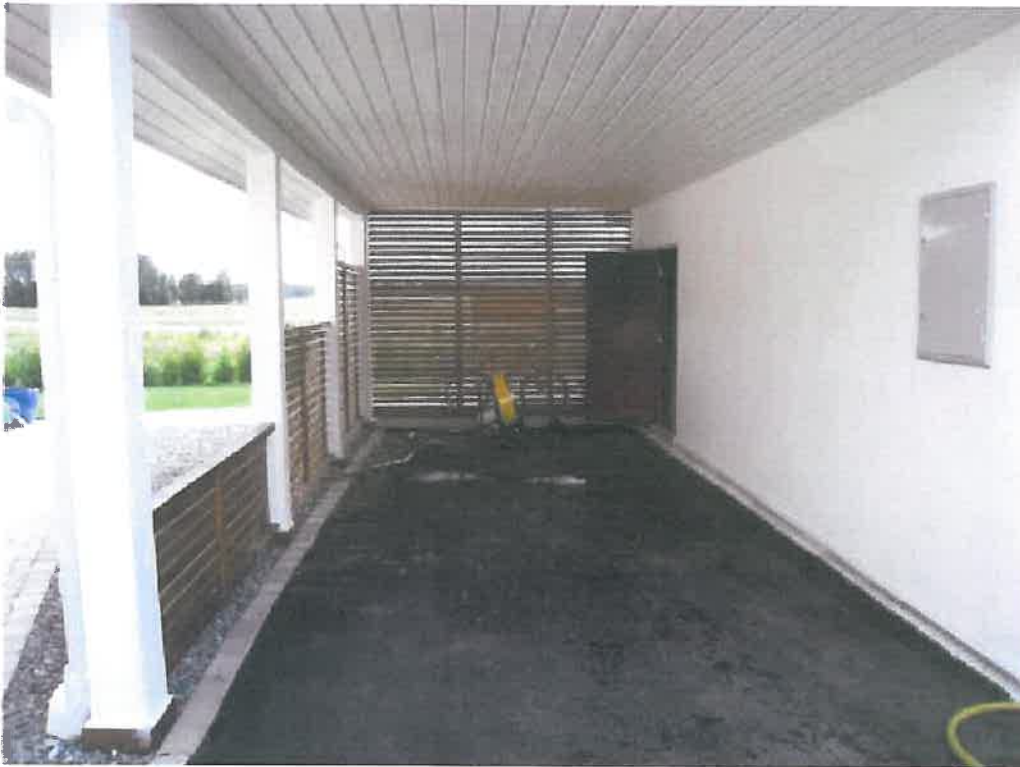
*Picture 1: Entry from the carport.*

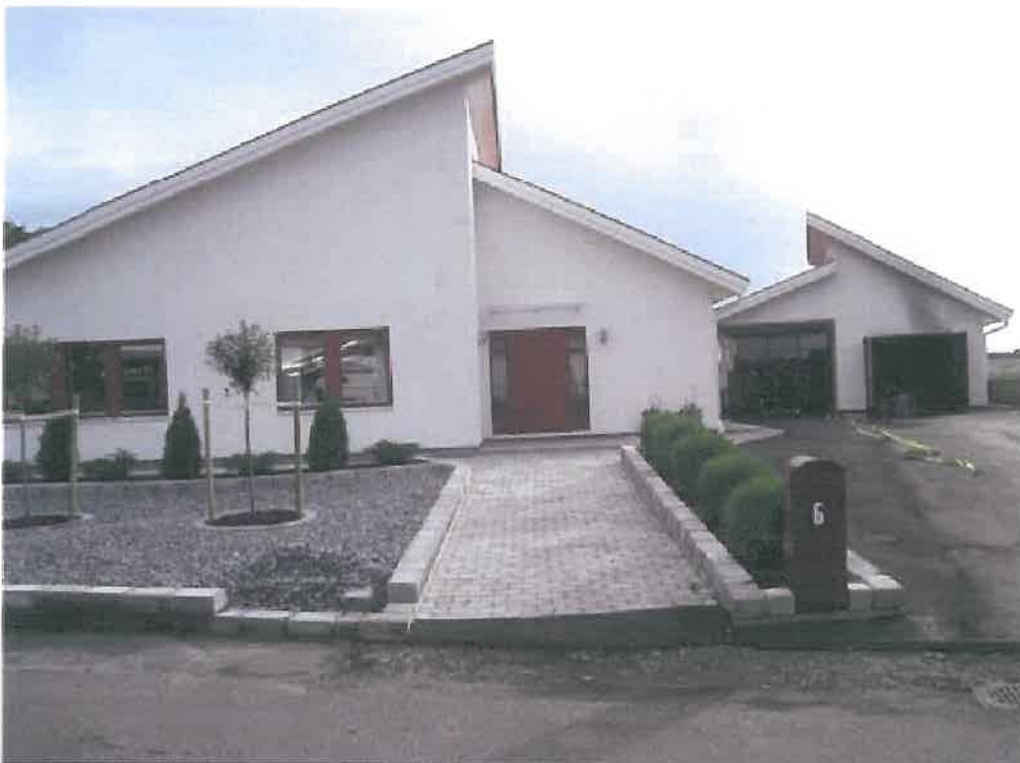
*Picture 2. Front view. Extinguished garage on the right*

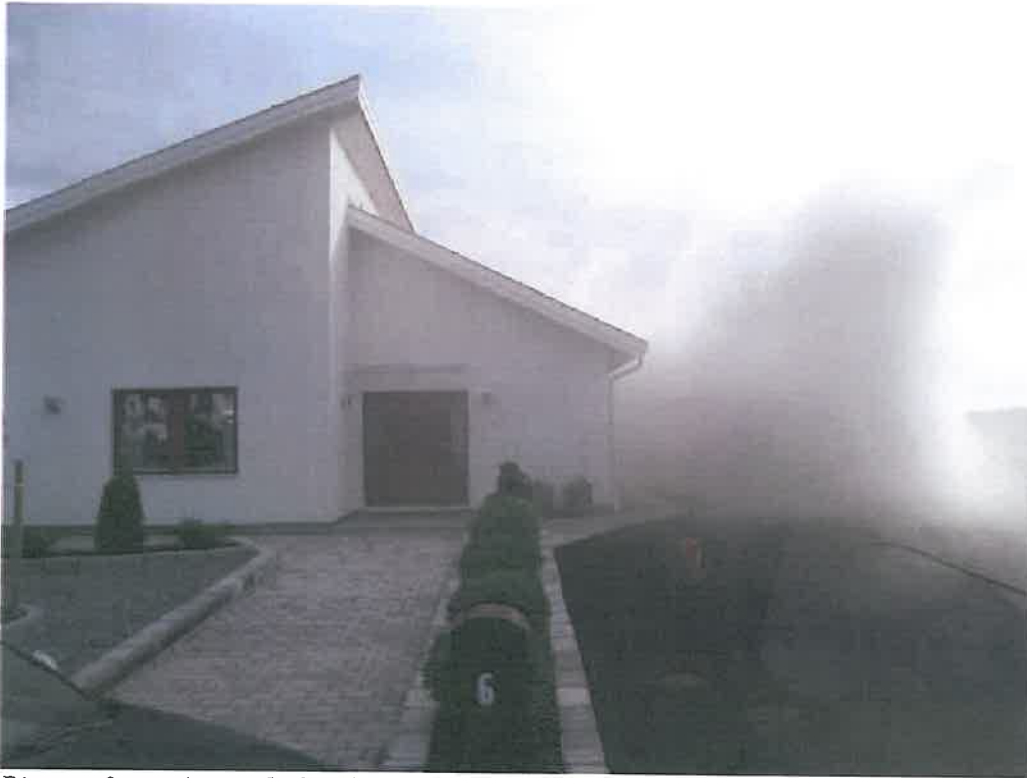
*Picture 3. Aerosol cloud from DSPA-5 deployment – front view*

We decided to use the DSPA-5. One unit was thrown into the garage. We waited for approximately 30 seconds before we started active ventilation to get the aerosol out of the compartment.

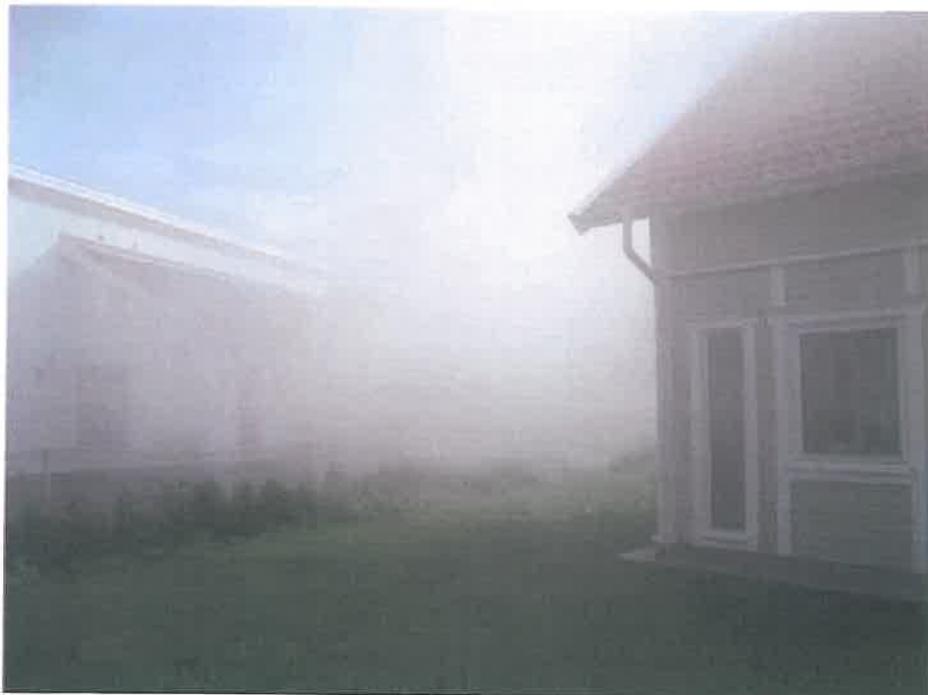
*Picture 4. Aerosol cloud from DSPA-5 deployment – back view*

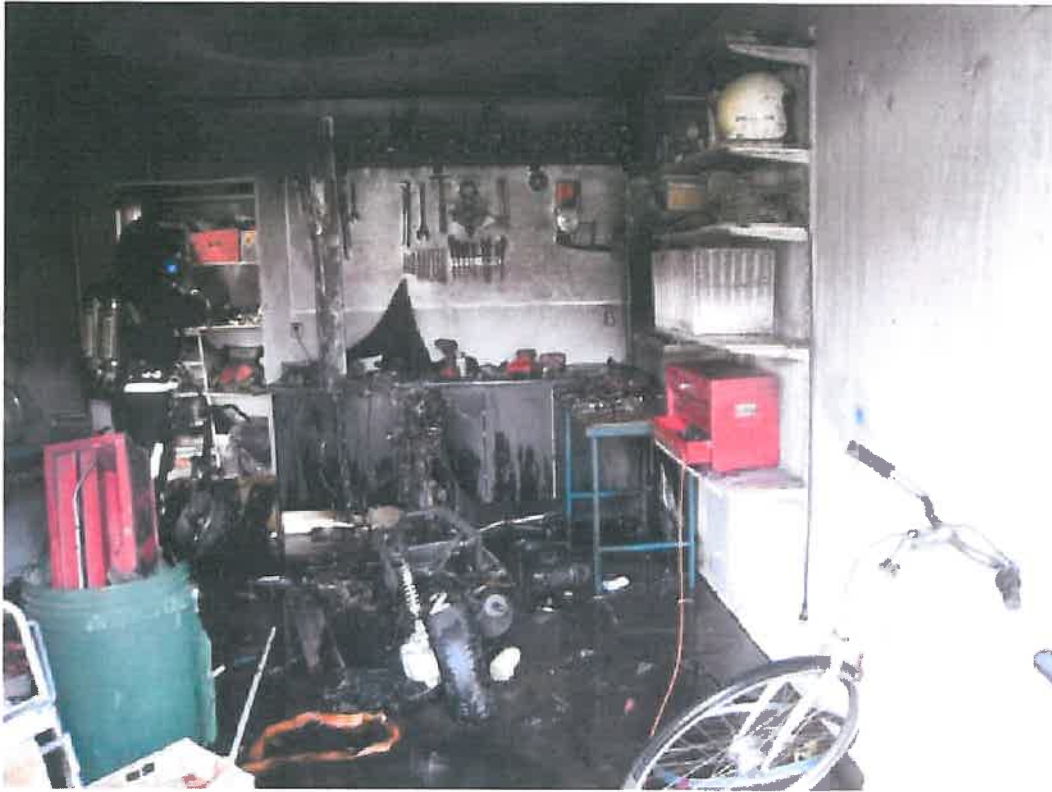
As we arrived the fire had spread to a workbench and surrounding equipment. The temperature was very hot in the roof region, a flashover was imminent. (Ventilation control).

Picture 5. *It was clear that it was very hot in the garage*

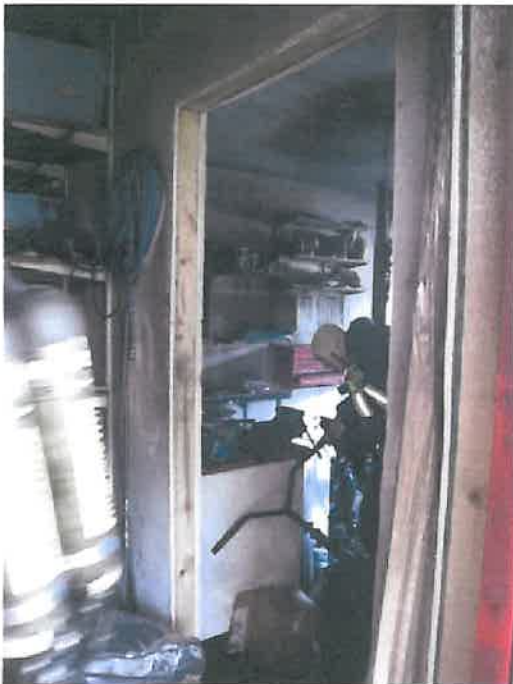
The door to the storage room next to the garage was open; therefore the fire was able to spread even further.

Picture 6. *The garage consisted of two rooms connected with an opening*

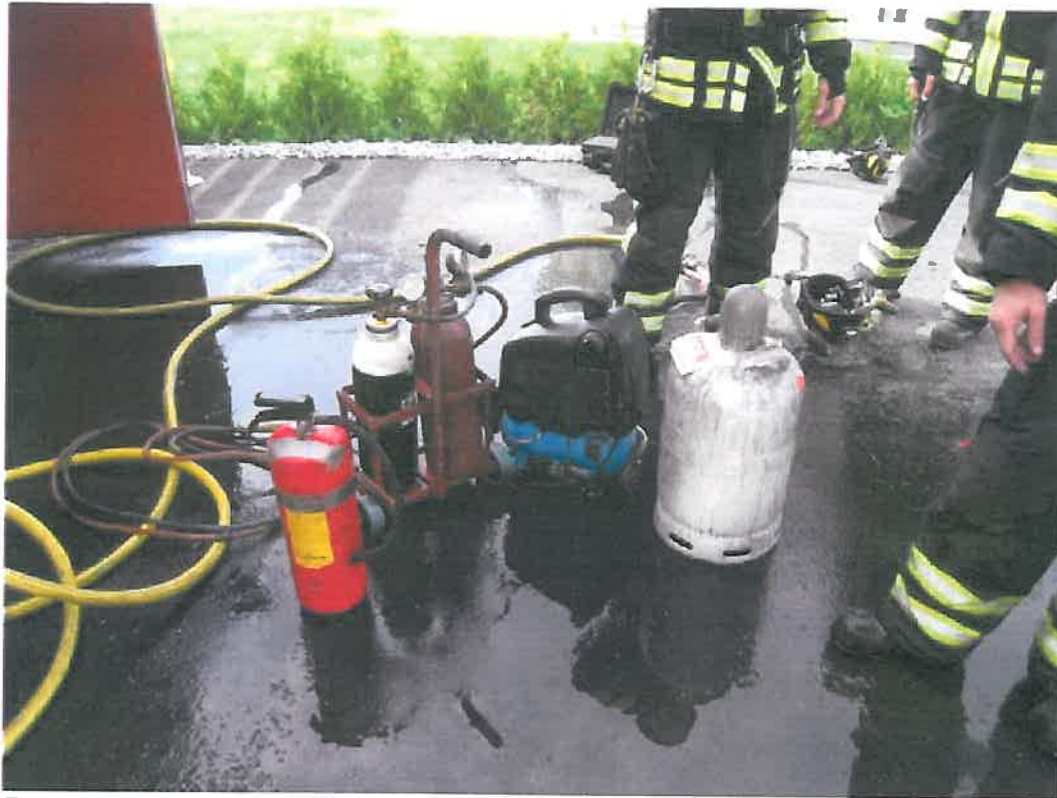
In the garage several gas cylinders and some welding equipment were stored.

Picture 7. Several gas cylinders were stored in the garage
